Office of Representative Steven Ultrino
33rd Middlesex District – Malden

2021 Malden Flooding Report

Flood Site 1 - Delta Terrace. Malden

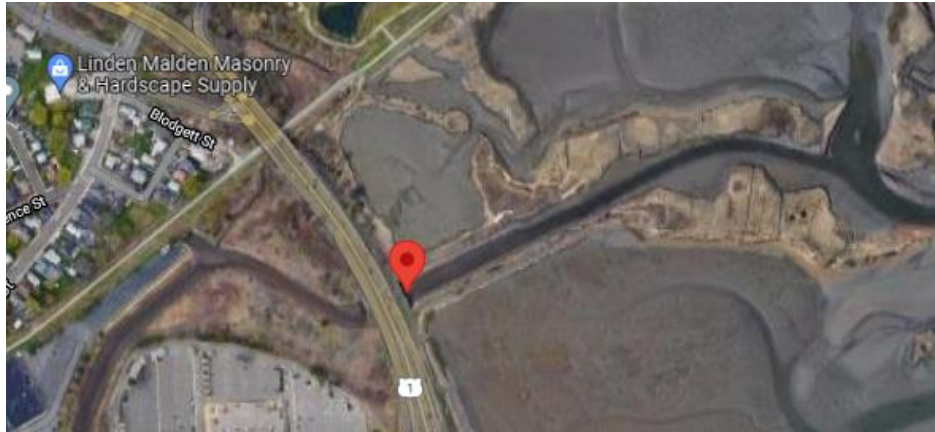
Gate Site 2 - Town Line Brook Tide Gate, Revere

October 13, 2021 – MassDOT conducts a site visit with District 4 drainage contractor. Findings include: Town Line Brook self-regulating tide gate #2 is listing due to a broken hinge; self-regulating tide gate #3 is fully detached and lying submerged downstream. See Appendix C, Figure 12.

October 14, 2021 – MassDOT commits to emergency action repair as they plan with DCR and City of Revere to conduct permanent repairs. Emergency action repair expected before weekend of 10.16.21. See Appendix C, Figure 12.

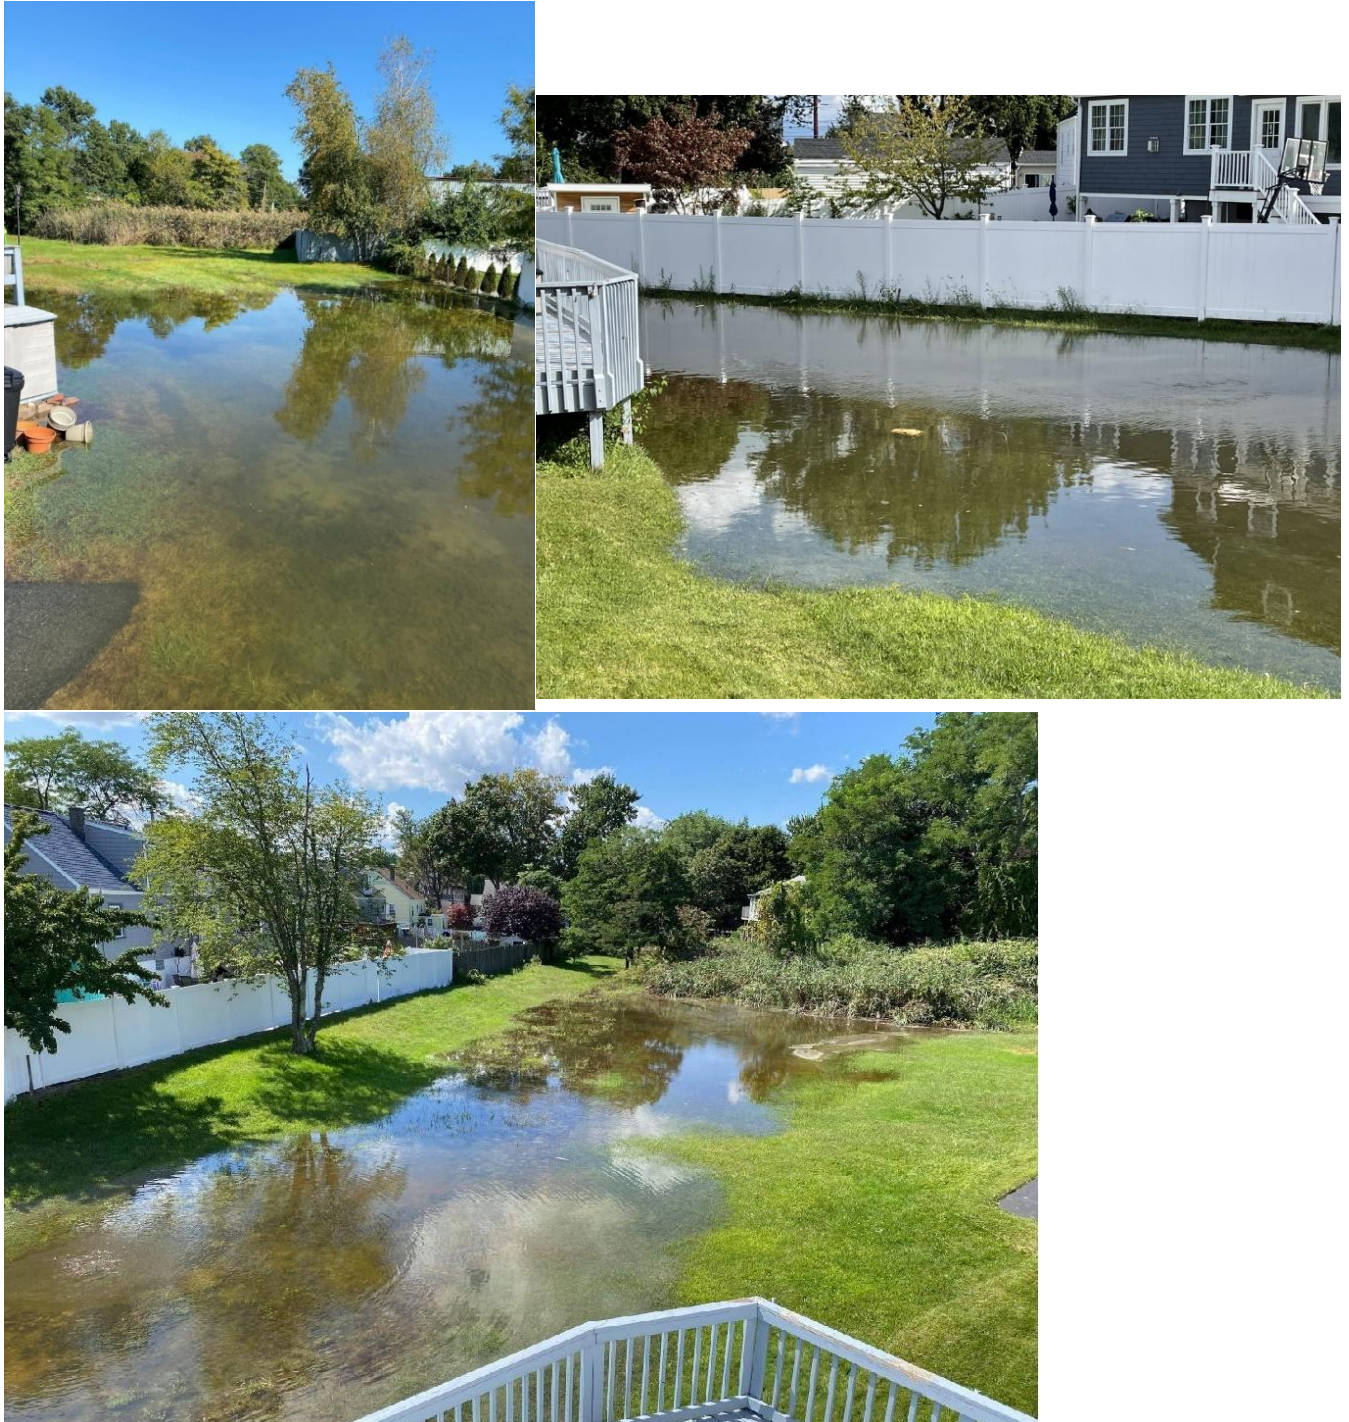
Flood Site 1 – Delta Terrace

[Click here](#) for video of Linden Brook Culvert's drop inlet surcharging during high tide.

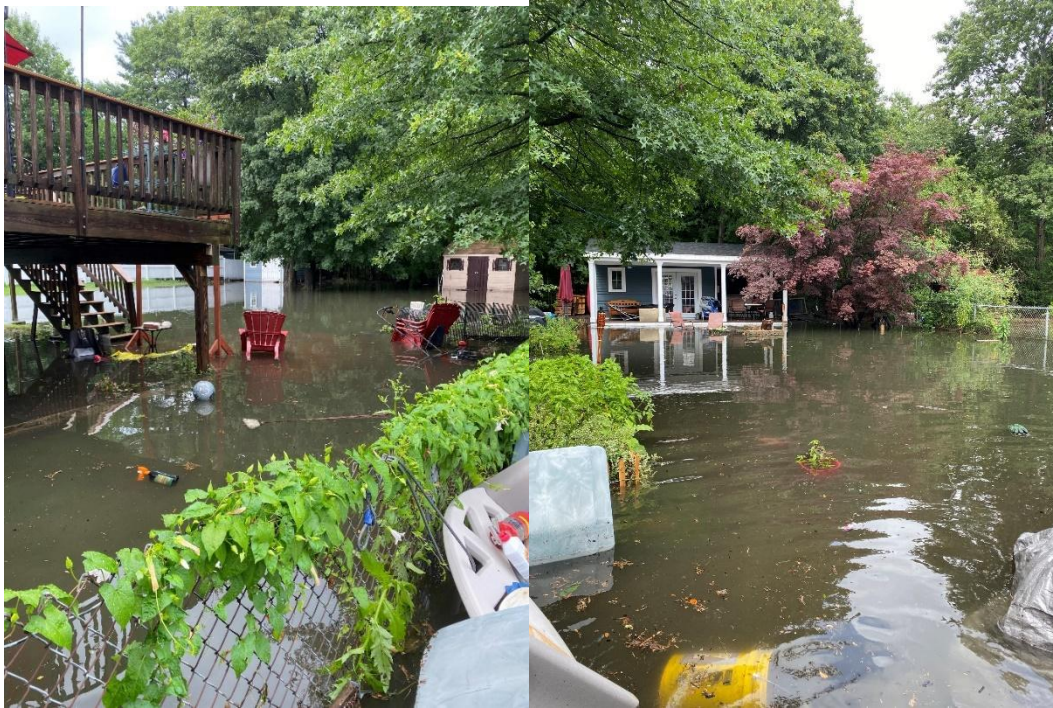
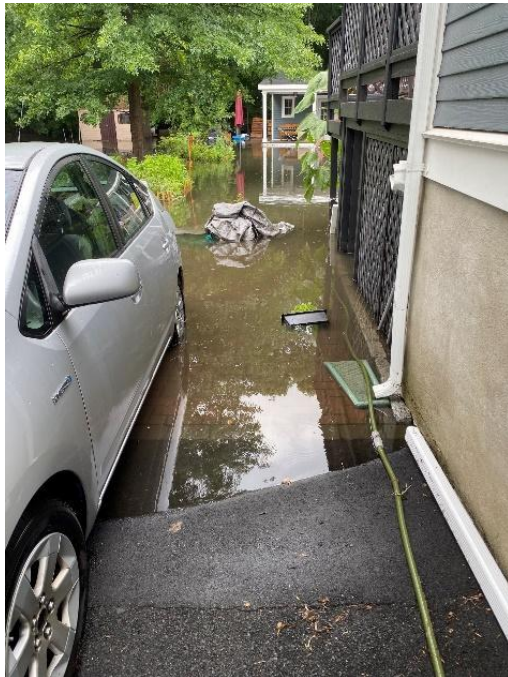
Flood Site 2 – Hadley Street

October 13, 2021 – Malden and Revere City staff and officials meet alongside Reps Ultrino and Giannino to discuss next steps. Malden Ward 8 Councilor Jadeane Sica raises flooding concerns on Hadley Street in Malden as potentially connected to Town Line Brook tide gate malfunction. The Town Line Culvert directly abuts Hadley Street and residents observed tidal flooding patterns similar to those observed at Delta Terrace by both residents and DCR staff.

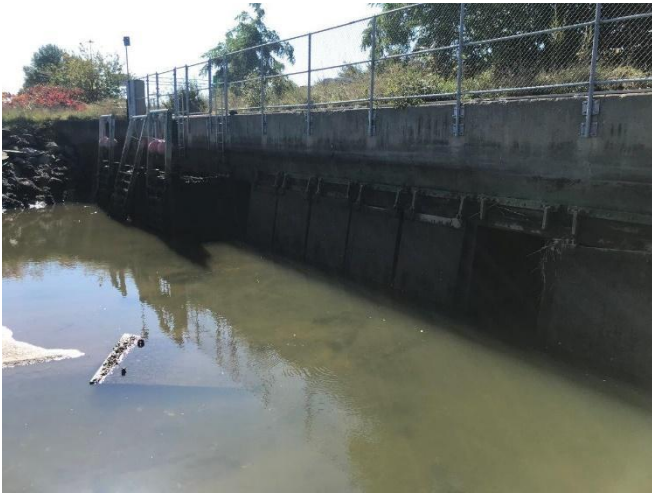
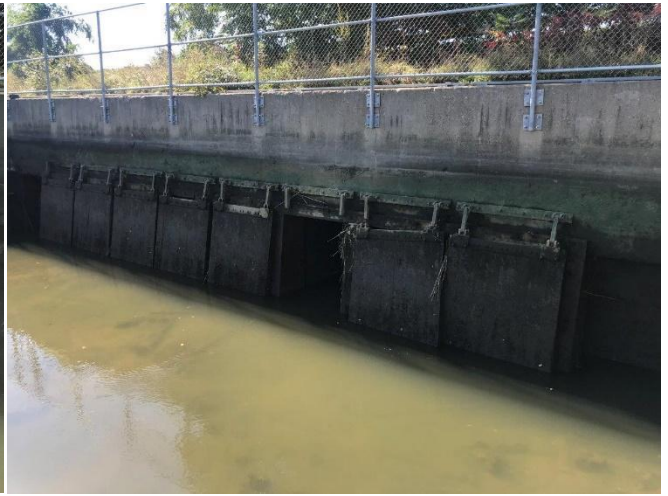
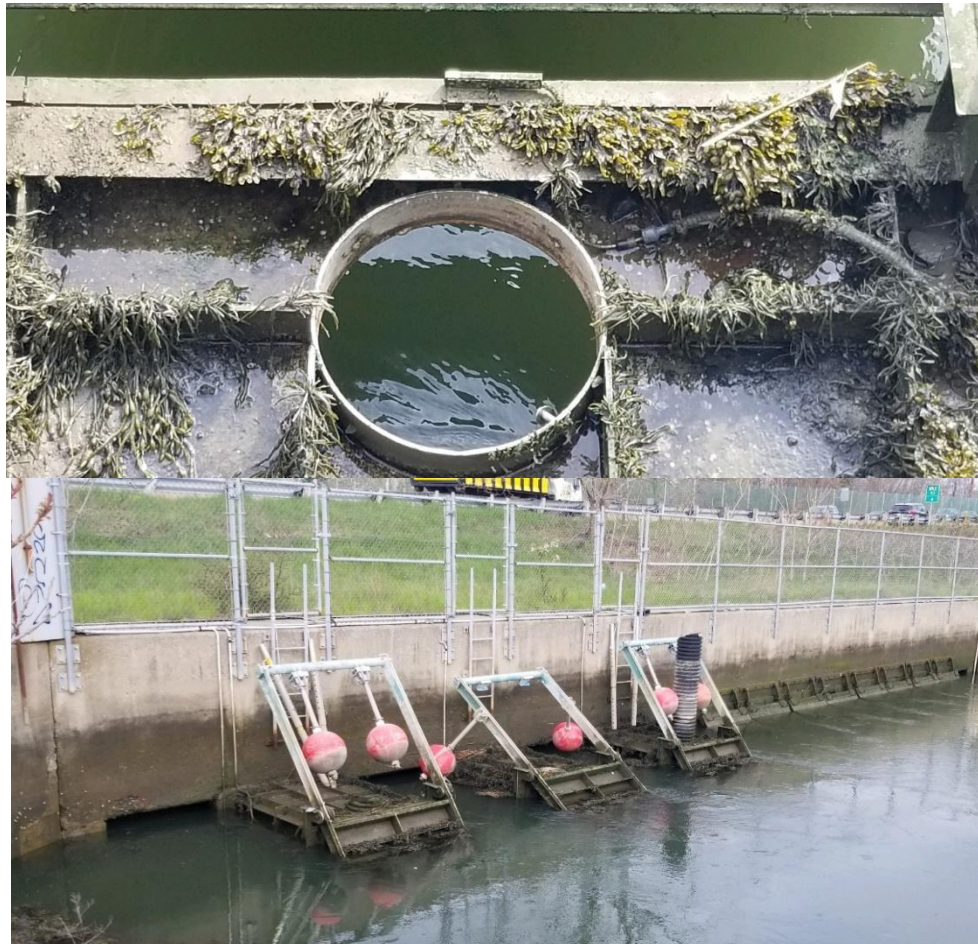
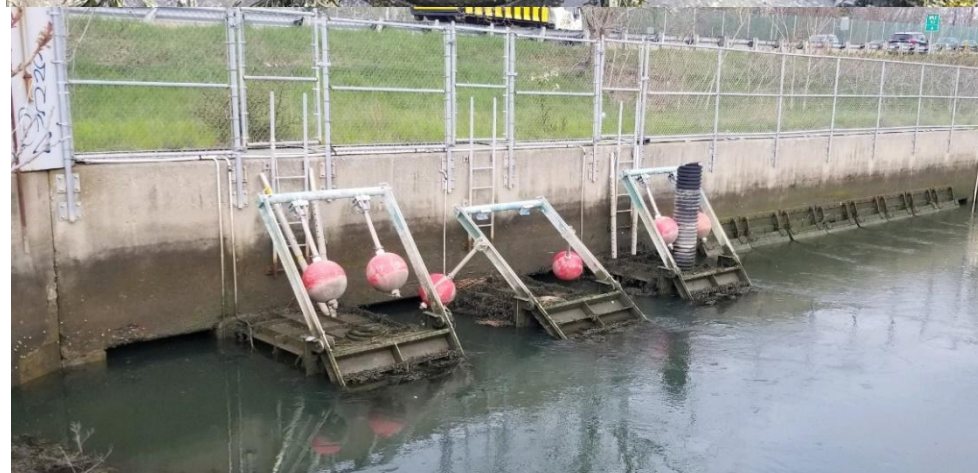
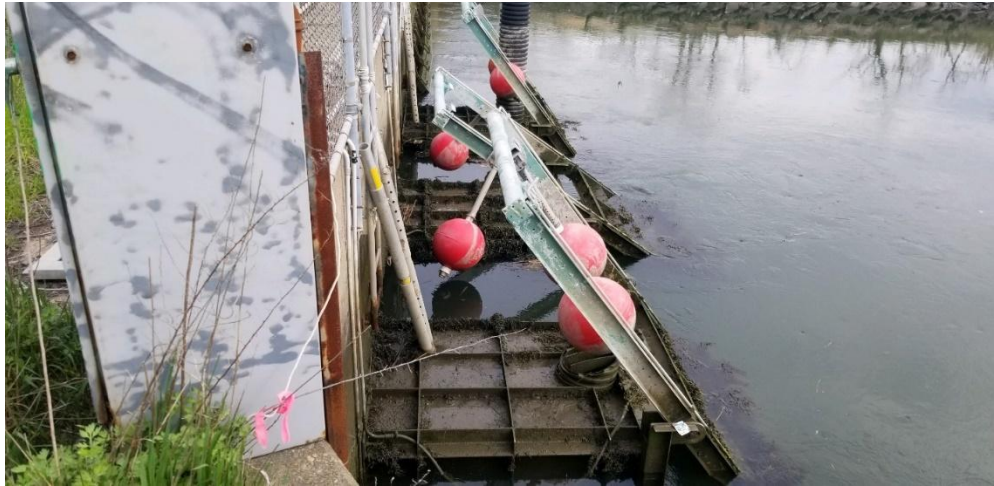
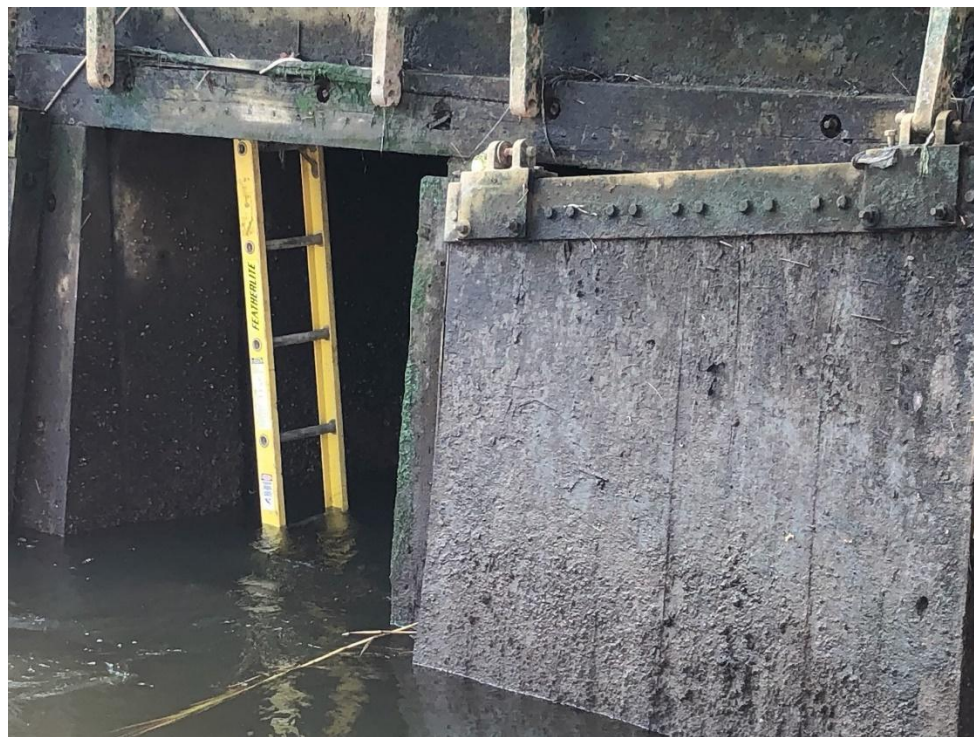
Gate Site 1 – Town Line Brook tide gates

5. Failed drainage infrastructure contributing to flooding includes:
- a. (2) dysfunctional self-regulating tide gates at the Town Line Bridge tide gates adjacent to Rt. 1 in Revere. Both tide gates' vent pipes sunk below mid-tide water levels, allowing significant amounts of water to bypass tide gates (identified 5.3.21 by John Ellis of Weston & Sampson on behalf of the City of Revere).

- b. (2) dysfunctional timber tide gate at the Town Line Bridge tide gates. One gate has a sheared hinge, preventing total gate closure and allowing in significantly higher volumes of water. The other tide gate completely sheared from both hinges, floating downstream (identified by City of Revere staff on multiple occasions).

[Click here](#) for video of leaking tide gates at Town Line Brook tide gates

ABOVE IMAGES AND VIDEO OF TOWN LINE BROOK TIDE GATES TAKEN BEFORE 10.14.21
EMERGENCY REPAIR COMPLETED BY CITY OF REVERE, BELOW IMAGE TAKEN AFTER.

11. Temporary emergency repairs have been made by the City of Revere. However, permanent repairs are still needed. DOT has committed to undertake these repairs working with DCR and the City of Revere.

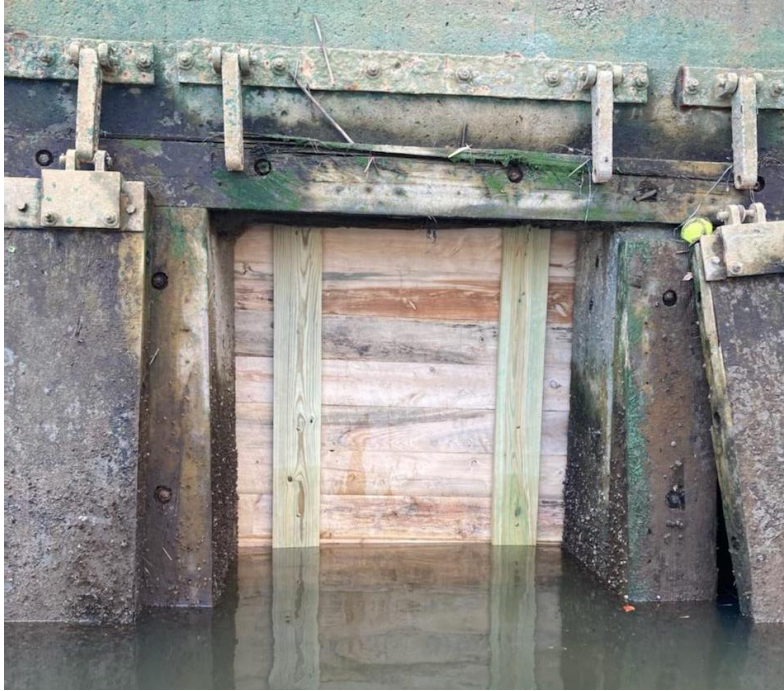
October 14, 2021 – City of Revere Water and Sewer staff conduct emergency action repair. See last photo in Appendix A, Gate Site 1.

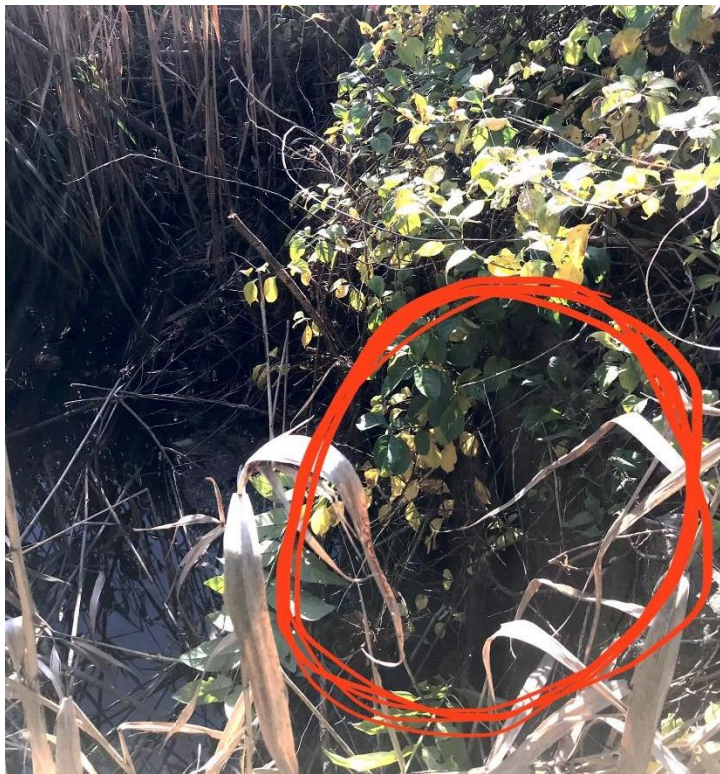
Gate Site 2 – Linden Brook tide gate

NB: The Linden Brook tide gate is a simple flap gate. The flap gate can be seen through the surrounding brush in the red circled area. Better pictures weren't possible when Ultrino staff visited without significant impact on Marshlands.
